The South Oculus at Canterbury Cathedral

Advanced Masters in Structural Analysis of Monuments and
Historical Constructions

The South Oculus at Canterbury Cathedral is a wrought iron space frame, consisting of two layers (Ferramenta and Grille) connected by tie bars (Pins). It is in very good condition despite its almost 850 years of history.

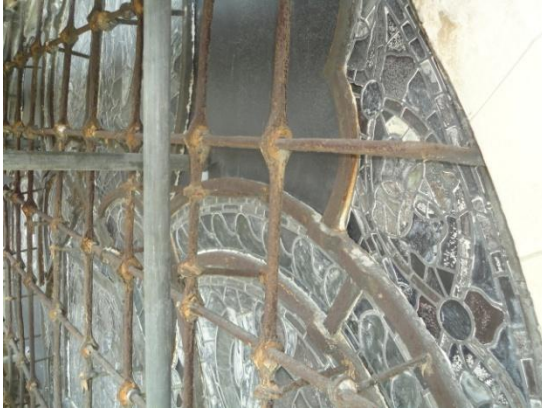
Figure 2-11 (a) The iron grille consisting of vertical and horizontal bars of round section - (b) Detail of the copper wedge used in the connection between the bars of the grille

The external layer consists of vertical and horizontal bars of round section which create an iron **grille**. The vertical bars are widening at regular intervals so the horizontal bars can pass through them (Figure 2-12a). The horizontal bars are restrained at the intersection with the vertical bars by copper wedges. The joint is then sealed with a lead putty to prevent water ingress (Figure 2-11b).

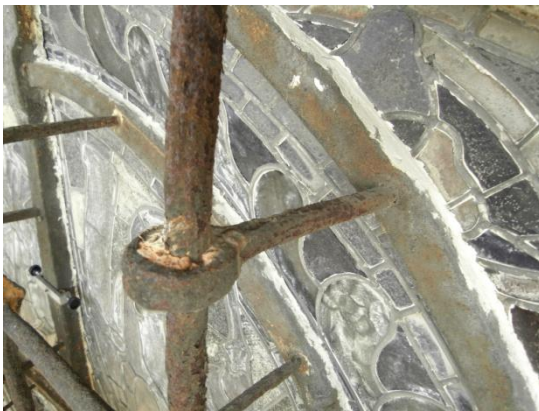
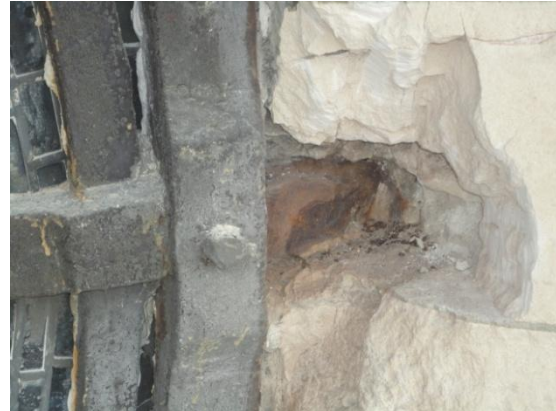
Figure 2-12 (a) Detail of an iron pin which connects the two layers of the space frame, (b) Fixing of the space frame into the masonry

The space frame is fixed into the masonry as Figure 2-12b shows.

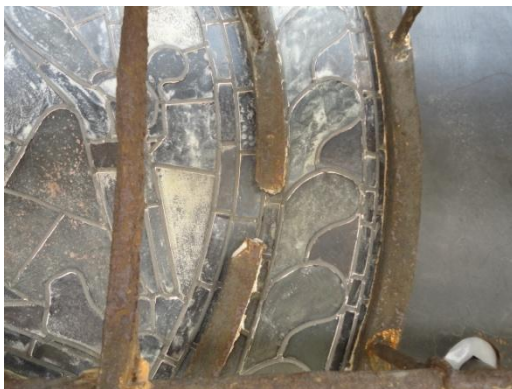
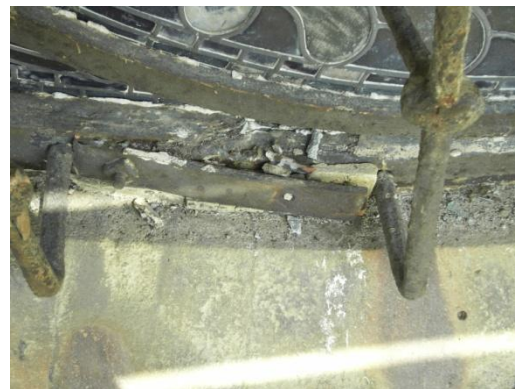
Figure 3-1 (a) Broken Ferramenta section – (b) Old repair at the Ferramenta circular ring

Except for one broken section, no damage was noticed in the Ferramenta members (Figure 3-1a). There are a number of old repairs but they do not seem to affect the stability of the structure (Figure 3-1b). Moreover, there is a coating of corrosion products on the iron's surface, but considering the environmental exposure and age, this corrosion level is considered low.

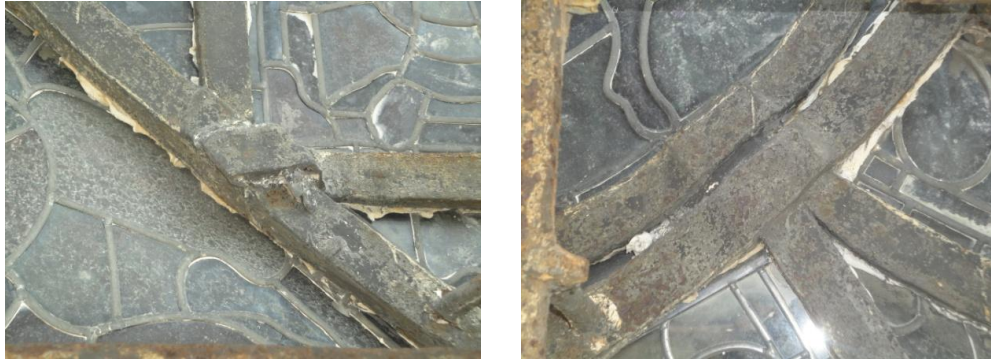
Figure 3-2 Detail of the connections condition in Ferramenta

The connections of the Ferramenta members are made using “mortise and tenon” joints by preheating the member with the mortise and are in very good condition. They will therefore be considered as rigid connections later in this work (Figure 3-2).

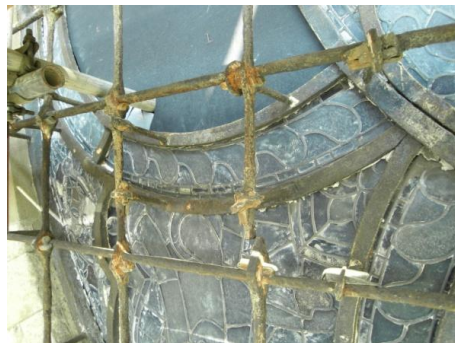
Figure 3-5 (a) Detail of the broken vertical grille bar – (b) Bar repaired using tube section

The third vertical grille bar from the left is broken (Figure 3-5a), whereas some bars were repaired by using tube sections (Figure 3-5b). These loose tubes should be removed as they are promoting corrosion to the iron grille (Hall 2011). Furthermore, the shape of the bars is not perfectly circular due to their exposure to the elements for so many centuries.

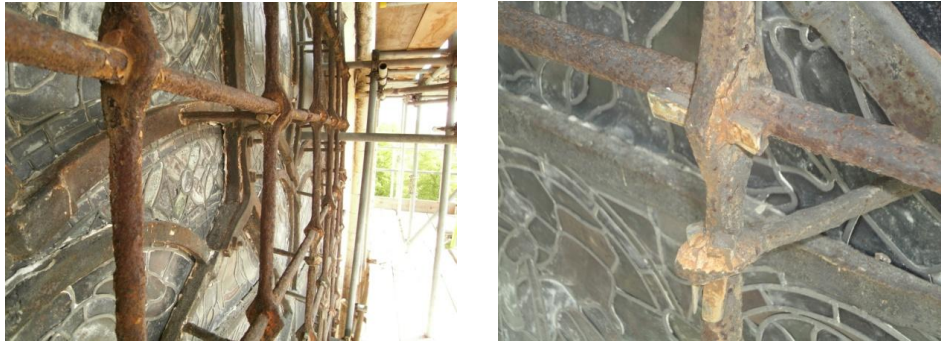
Figure 3-6 Detail of the grille bars connections

The horizontal bars are passing through the vertical bars and they are joined together by using copper wedges and lead putty (Figure 3-6). We will see later in this work that these connections of the grille will not be considered rigid, but semi – rigid. The grille connections are in very good condition and no loss of material can be observed. In addition, the presence of dissimilar materials at the grille joints (wrought iron, copper and putty) could cause electrochemical (galvanic) corrosion, which seems not to be occurring (Hall 2011).

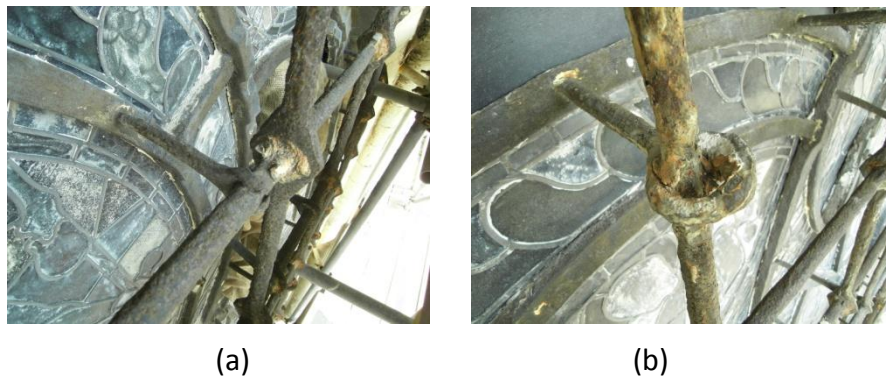
1. Destroyed pin “eye” because of the deterioration
2. Loss of wedges and putty

Figure 3-10 (a) Type of Failure 1 – (b) Type of Failure 2

The connections of the pins to the Ferramenta (cold rivets) are in good condition and will be assumed as rigid later in this work. On the contrary, the pins are joined to the grille bars by using copper wedges and lead putty. This type of connection will be considered as semi – rigid. The grille - pin joints were inspected one by one and two types of failure were identified (Figure 3-10):

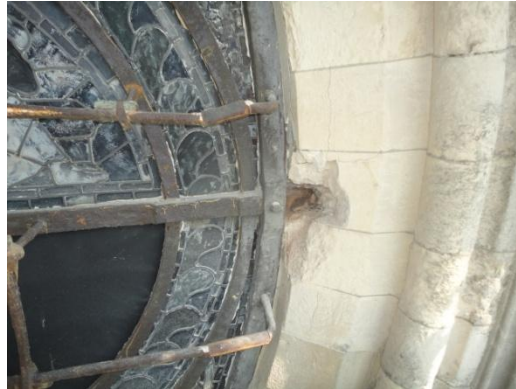
Figure 3-16 Stone detachment at anchor point (picture taken after local opening up)

In general, the masonry is in very good condition except the anchor point at three o' clock where stone detachment can be noticed (Figure 3-16). This damage is from rust jacking of the iron fixings promoted by water ingress to the stone through failed pointing and joints (Hall 2011).

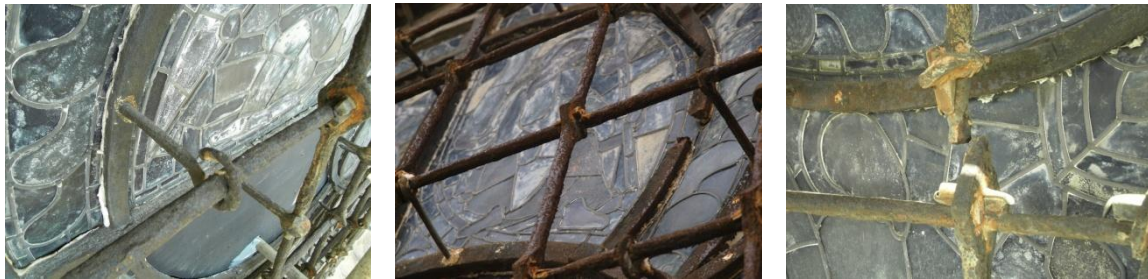
Figure 4-8 Damage imported into the finite element model CCF2
